SUMMARY OF OJAI CREEK CONDITIONS

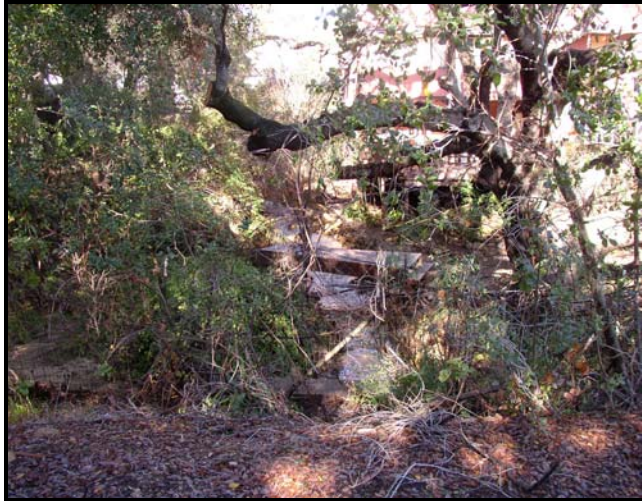
Photograph 63 (left). Arbolada Creek Reach 1 (7 December 2004).
Photograph 64 (right). Arbolada Creek Reach 2, view north (30 September 2004).

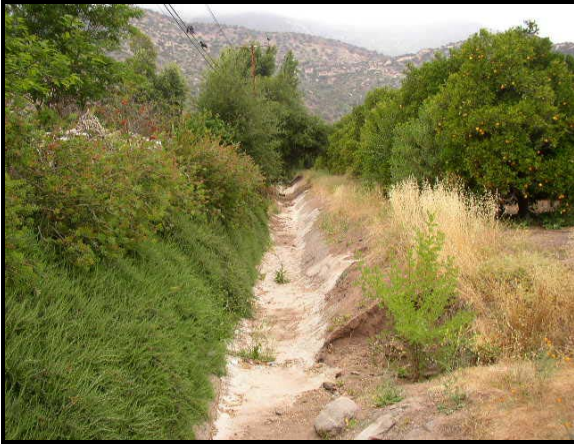
Photograph 65 (left). Ayers Creek (27 May 2004).

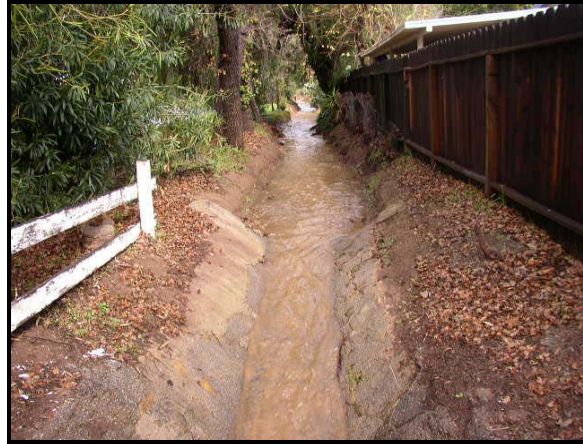
Photograph 66 (right). Ayers Creek (3 January 2005).

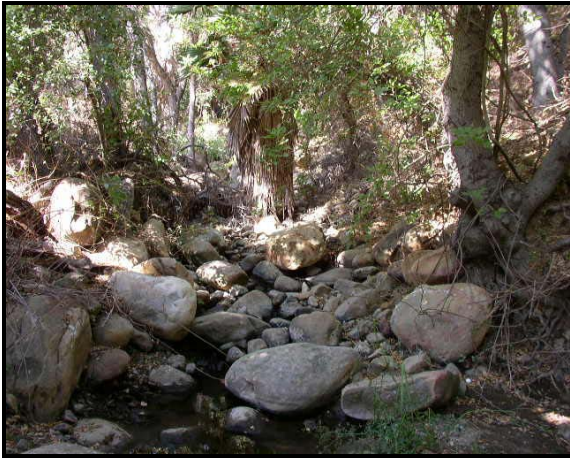
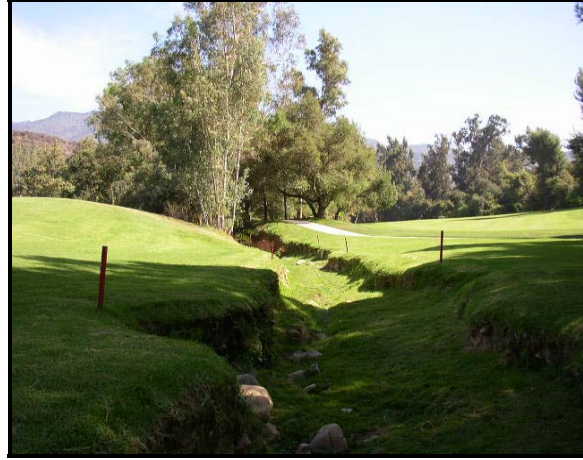
Photograph 67 (left). Del Norte Creek view north. Photograph 68 (right). Del Norte Creek view south. Photos taken 19 August 2004.

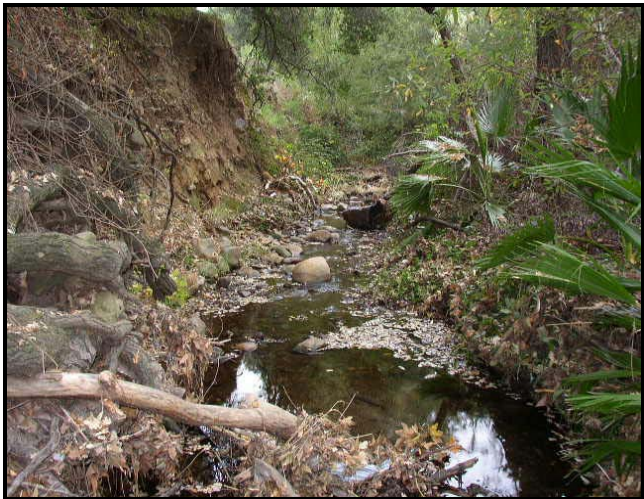
Photograph 69 (left). Fox Canyon Barranca Reach 1 above S. Ventura St. bridge (27 November 2004).

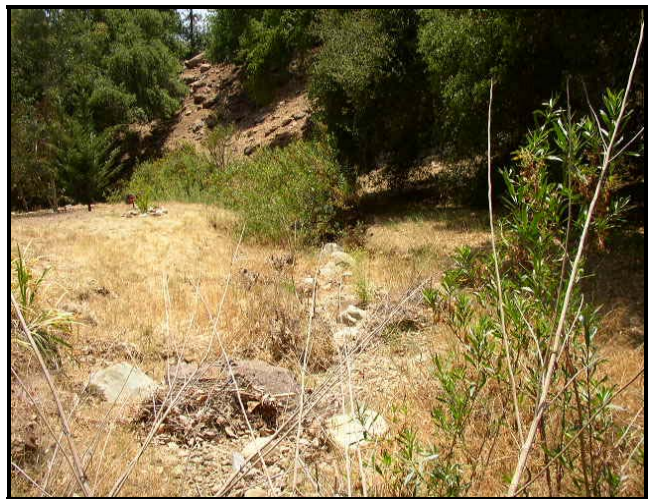
Photograph 70 (right). Fox Canyon Barranca Reach 4 above N. Montgomery St. (27 May 2004).

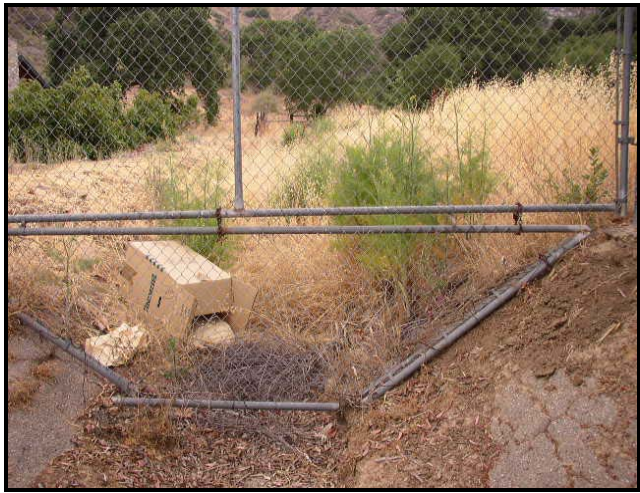
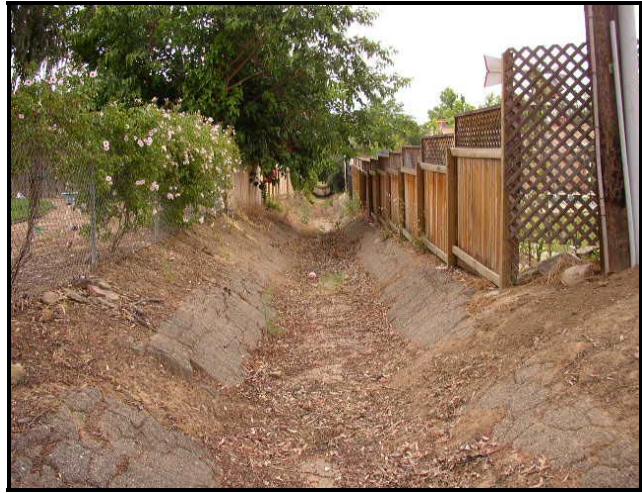
*Photograph 71 (left). Grandview-Park Drain above housing tract.
Photograph 72 (right). Grandview-Park Drain near Topa Topa Elementary School. Photos taken 27 May 2004.*

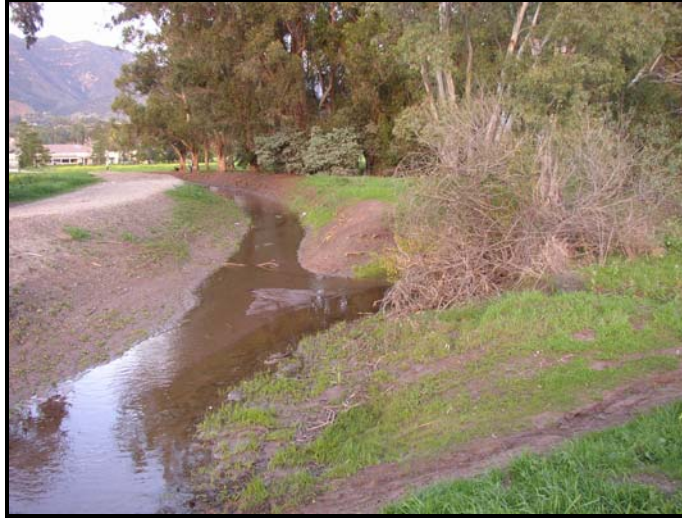
Photograph 73. Confluence of Happy Valley Drain (veering to the left) and Nordhoff Drain (veering to the right), view northeast (15 January 2005).

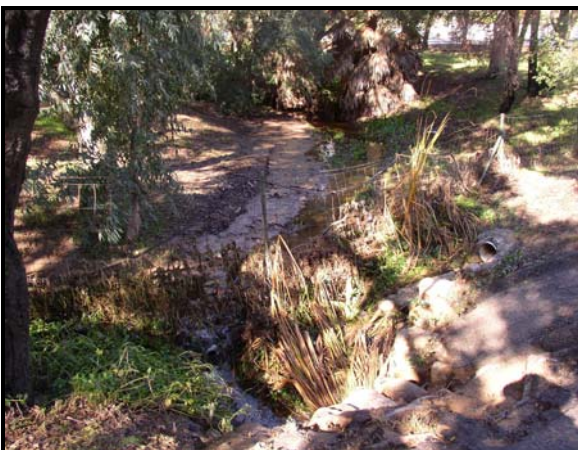
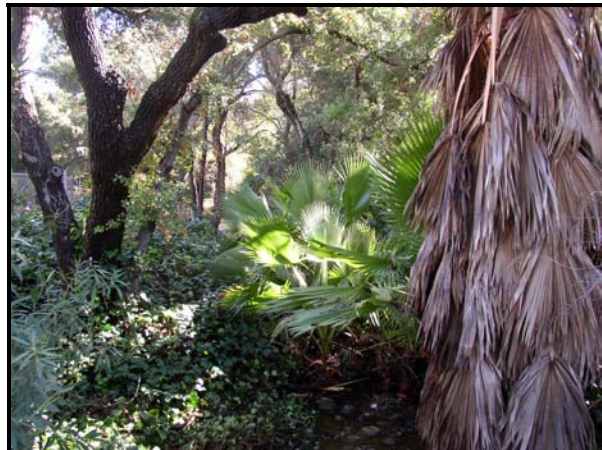
Photograph 74 (left). Oak Creek view upstream, at the end of San Antonio Street. **Photograph 75 (right).** Oak Creek view downstream, at the end of San Antonio Street. Photos taken 11 January 2005.

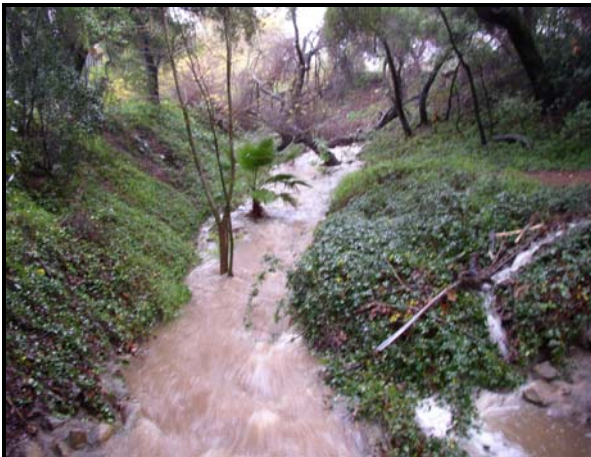
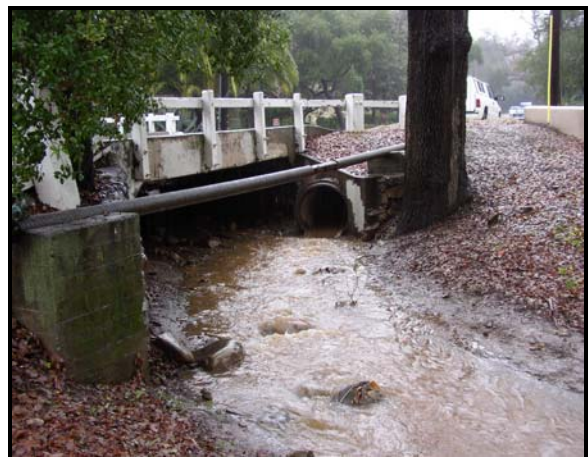
Photograph 76 (left). Ojai Creek Reach 1 at lower end next to lower Libbey Park tennis courts (5 January 2005).
Photograph 77 (right). Ojai Creek Reach 3 at Lion Street, high flows during winter storm event (5 January 2005).

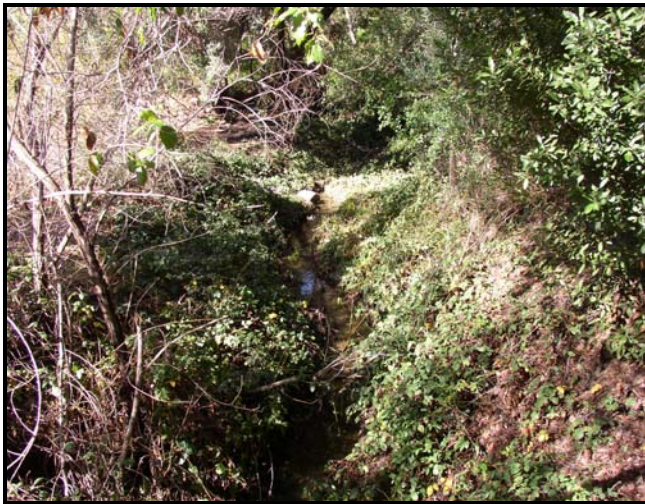
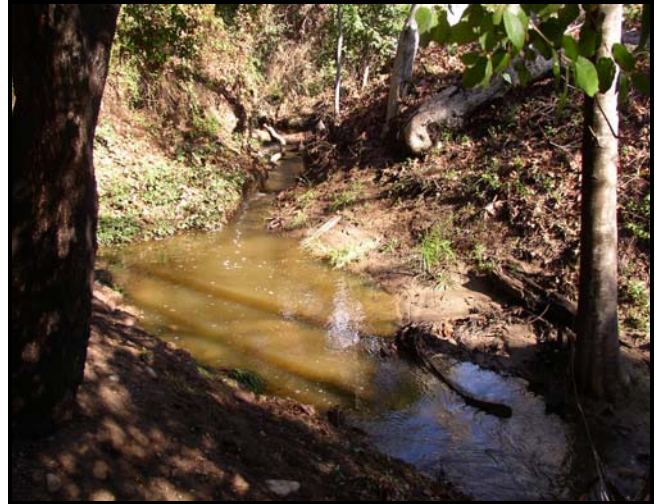
Photograph 78 (left). Post Office Creek just above confluence with Ojai Creek. **Photograph 79**. (right) Confluence of Ojai and Post Office Creeks with Ojai Creek prominent in photograph. Photos taken 11 January 2005.

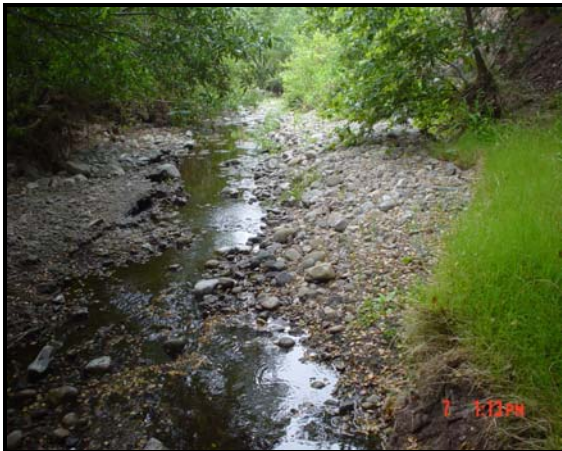
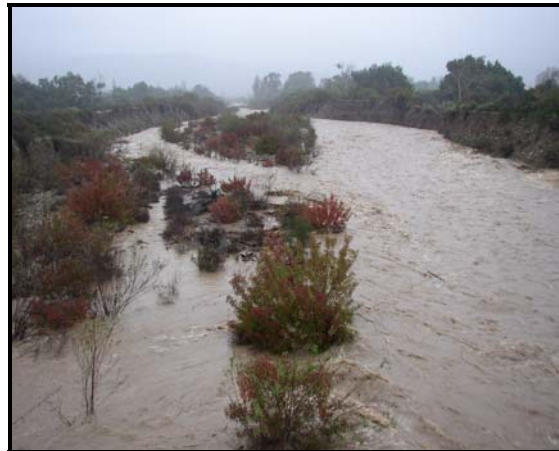
Photograph 80 (left). San Antonio Creek showing high-quality riparian/aquatic habitat with summer flows (16 July 2004). **Photograph 81** (right). San Antonio Creek with peak flows during winter storm (9 January 2005).

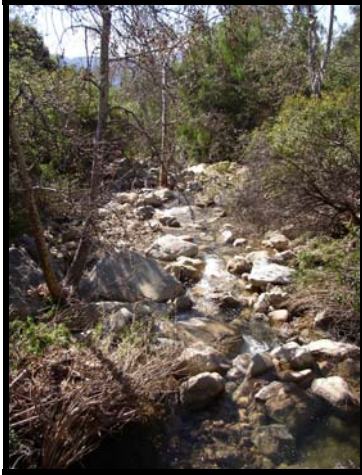
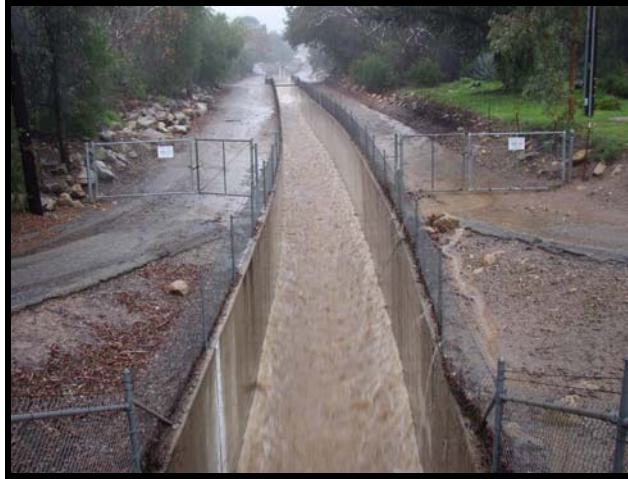
Photograph 82 (left). Stewart Canyon Creek Reach 5 with functional riparian habitat (24 January 2005).
Photograph 83 (right). Stewart Canyon Creek channelized Reach 4 showing peak flows during winter storm, view north (9 January 2005).

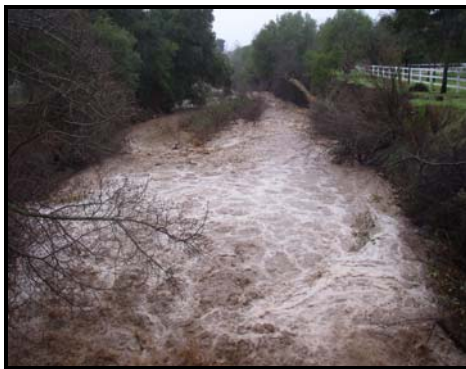
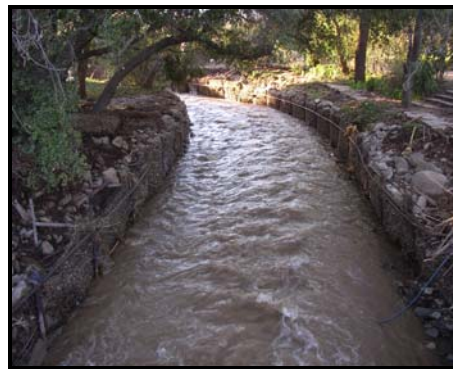
Photograph 84 (left). Thacher Creek below Boardman Road (9 January 2005).
Photograph 85 (right). Thacher Creek at Siete Robles Tract (12 January 2005).

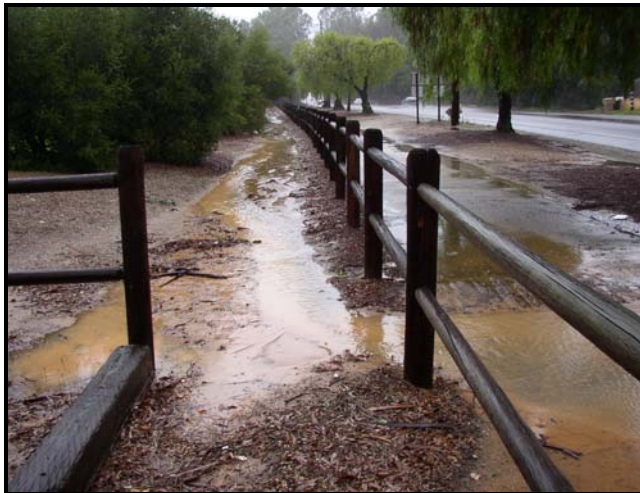
Photograph 86 (left). Drainage to Villanova Creek at Hermosa Rd along Ojai Bike Path.

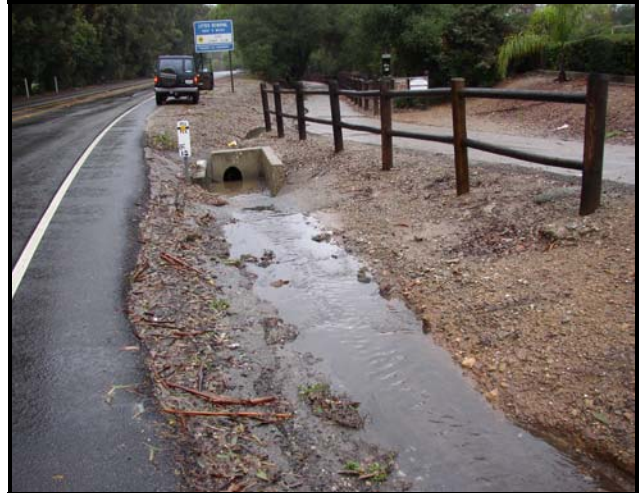
Photograph 87 (right). Drainage to Villanova Creek (upper end) along Ojai Bike Path. Photos taken 8 January 2005.
