**TREE PROTECTION PLAN
FOR THE MALIBU JEWISH CENTER &
SYNAGOGUE, 24855 PACIFIC COAST
HIGHWAY, MALIBU, CALIFORNIA**

September 2014, Updated September 2017

**Tree Protection Plan
for the Malibu Jewish Center & Synagogue,
24855 Pacific Coast Highway, Malibu,
California**

29 September 2014, Updated 17 September 2017

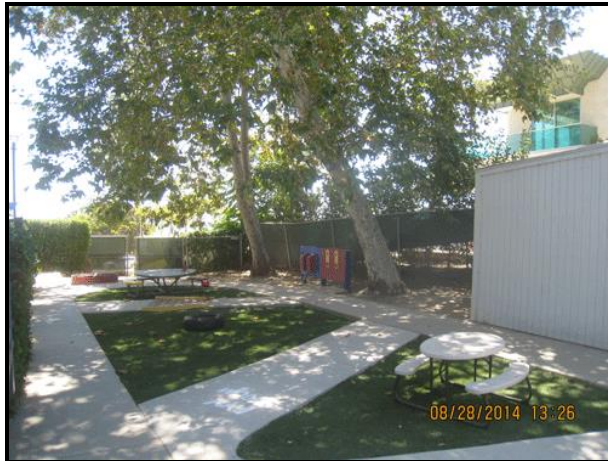
Photo 1 (left): Trees 1 & 2, Western Sycamore (Platanus racemosa) existing in the toddler playground on the west edge of the property, required for removal.

The proposed project will result in the unavoidable removal and loss of two (2) Western Sycamore trees. DMEC recommends that this loss of these two trees be mitigated onsite by planting of Western Sycamore at a ratio of no less than 10-to-1.

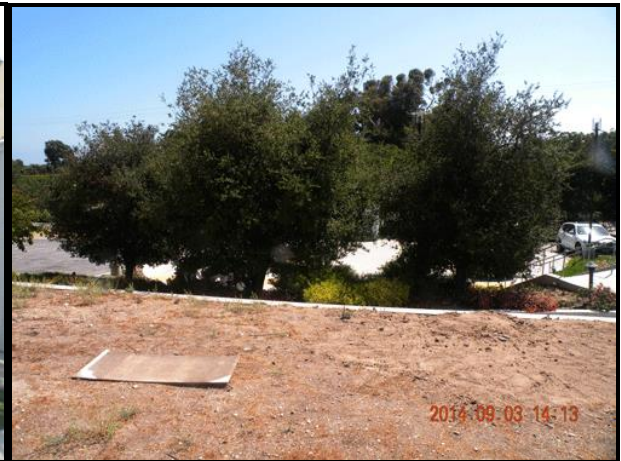
Photo 2 (right): Trees 19,20, & 21, Coast Live Oak (Quercus agrifolia) existing in a landscaped area and required for removal where planted onsite in 2006.

In addition, the proposed project may result in the encroachment of the TPZ and potential harm of three (3) planted Coast Live Oak trees. DMEC recommends that these three trees be protected during construction by erecting a temporary fence around the TPZ of these trees to the maximum extent possible and monitored by a Certified Arborist immediately prior to start of construction, as illustrated in Figure 5. Following completion of construction activities, DMEC recommends these trees be managed and monitored annually by a Certified Arborist for a period of no less than five (5) years to determine their health, or decline in health, as a result of construction within their TPZs. In the event that the trees are damaged by/during construction, DMEC recommends that the loss of these three trees be mitigated by onsite planting at a ratio of no less than 10-to-1.

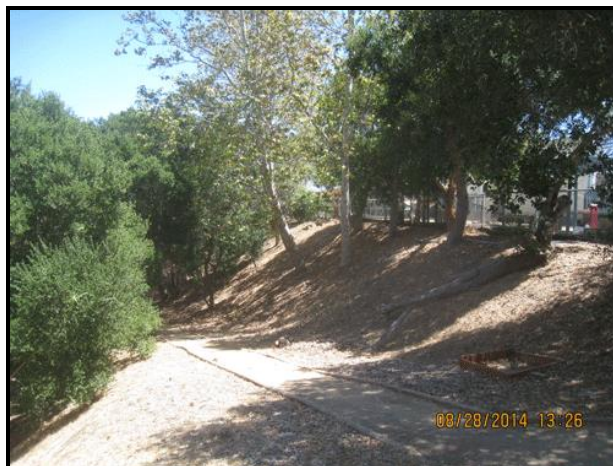
Photo3 (left): Mixed Oak-Sycamore Woodland existing north of the proposed project footprint, general location of trees 3 through 18.

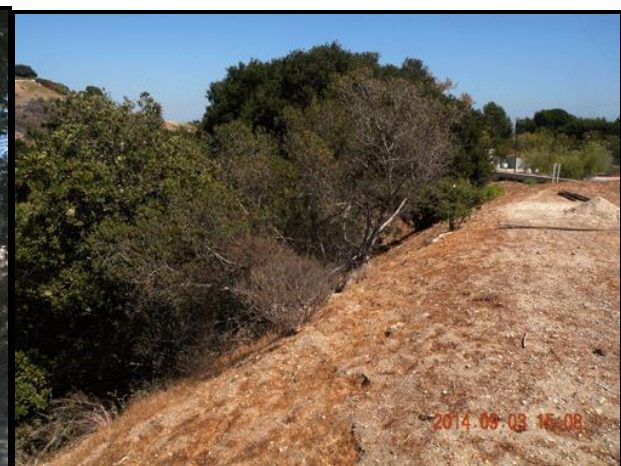
Photo 4 (right): Oak-Walnut Woodland northeast of the proposed project footprint existing on a steep north facing hillside.

The proposed project may result in potential significant impacts to mixed Coast Live Oak-Southern California Black Walnut Woodland located north and northeast of the project footprint. Significant impacts would occur as a result of substantial runoff or dumping of fluids/sediments/debris down the north-facing hillside, upon which the woodland occurs. DMEC recommends establishment of a temporary fence, placed several feet back from the edge of the hillside, to prevent such dumping or runoff. The approximate location of this fencing is illustrated in Figure 5.

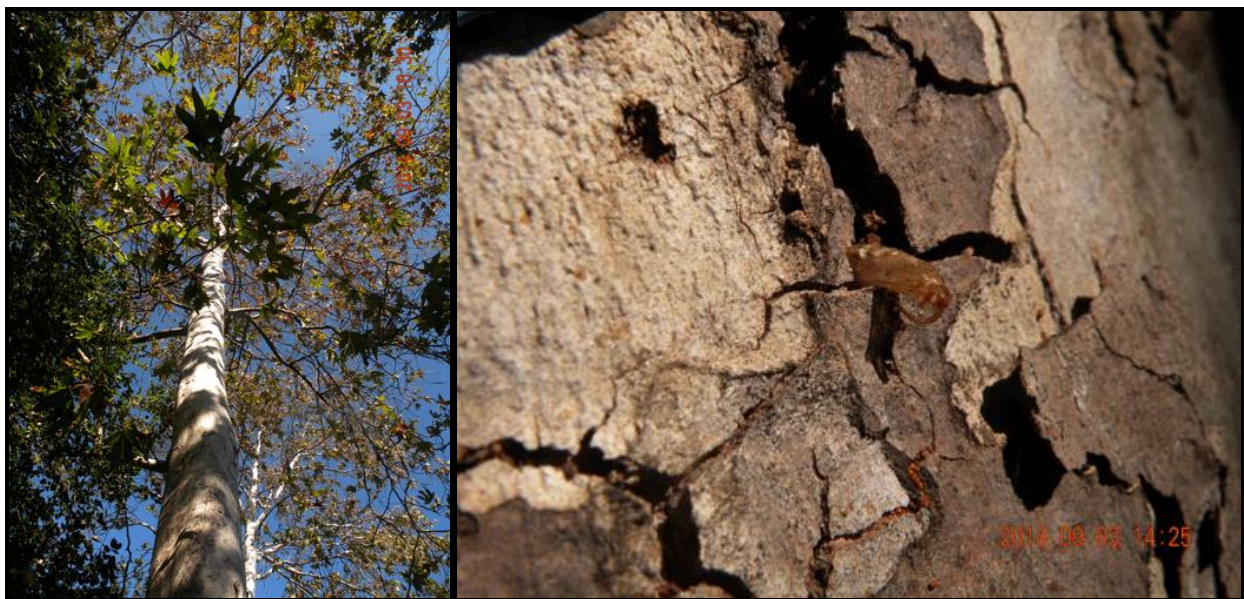
Photo 5 (left): Tree #13, Western Sycamore (Platanus racemosa), in generally good condition with sound trunk but somewhat sparse canopy.

Photo 6 (right): Tree #2, Western Sycamore (Platanus racemosa), bark borer insect molt and some frass visible on the trunk..

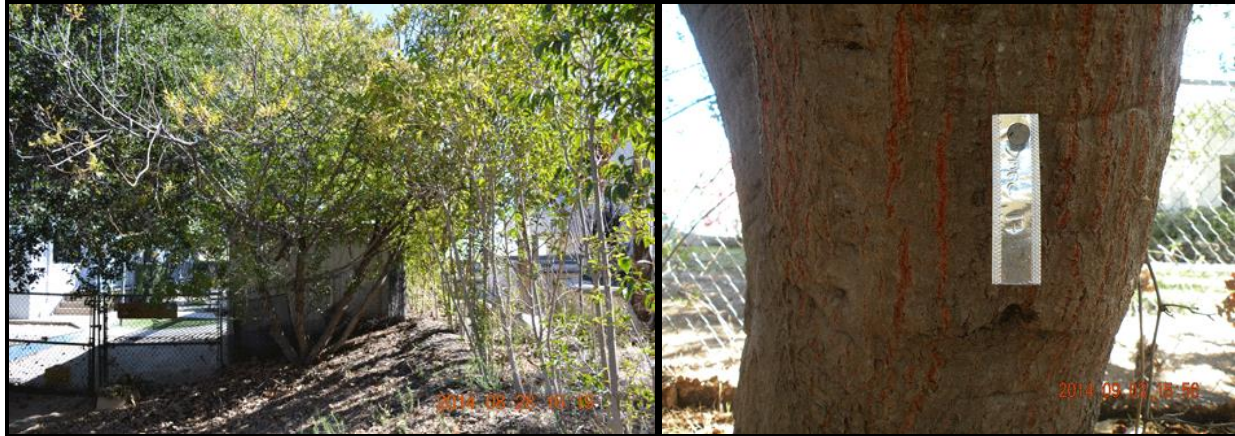
*Photo 7 (left): Tree #3, Southern California Black Walnut (*Juglans californica*), in generally good condition near the northwest corner of the proposed project footprint.*

*Photo 8 (right): Tree #17, Coast Live Oak (*Quercus agrifolia*), DMEC assigned number tag and trunk with significant new growth visible.*

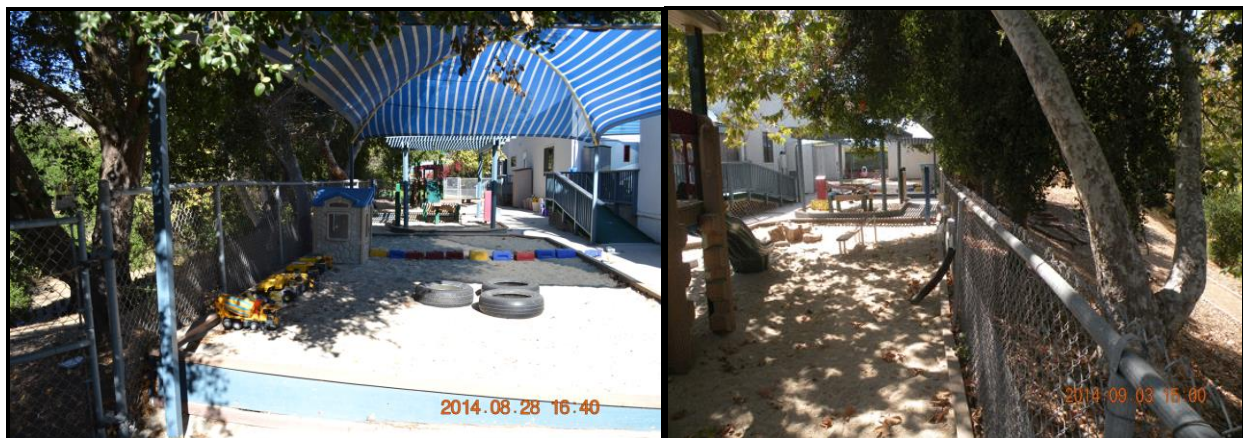
Photo 9(left): View east from near the northwest corner of the proposed project footprint of playground and sandbox area to be preserved. Photo 10(right): View west from north of the proposed project footprint of playground and sandbox area to be preserved.
