**ASSESSMENT OF
EUCALYPTUS TREES AT CAPE MASTER
AND THE CAPE DEVELOPMENTS**

April 2009

David Magney Environmental Consulting

17 April 2009

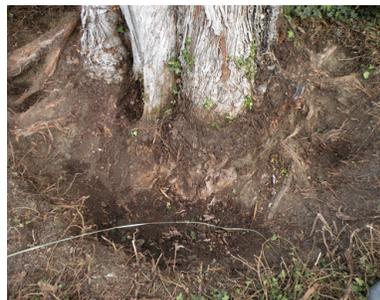
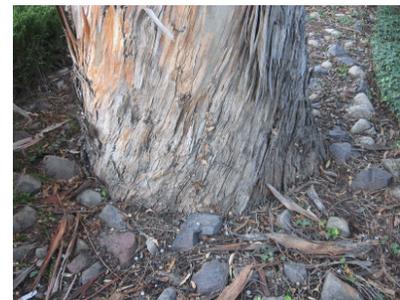
Excess fill needs to be removed from the base on nearly all the trees to expose the root crowns to proper levels, ranging between 6 to 18 inches.

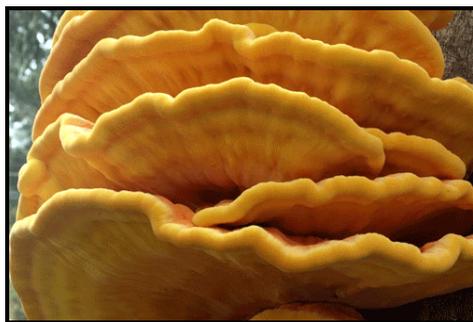
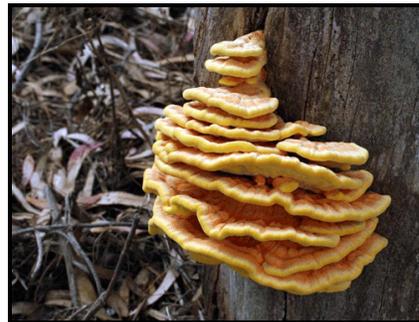
Tree #14 is recommended for removal since its trunk is infected by a damaging fungus (*Laetiporus gilbertsonii*) that is known to eventually kill Eucalyptus trees. This fungus causes rot of the heartwood, and will eventually kill the tree. The fungal attack is likely the result of fill material being placed over the root crown several years previous.

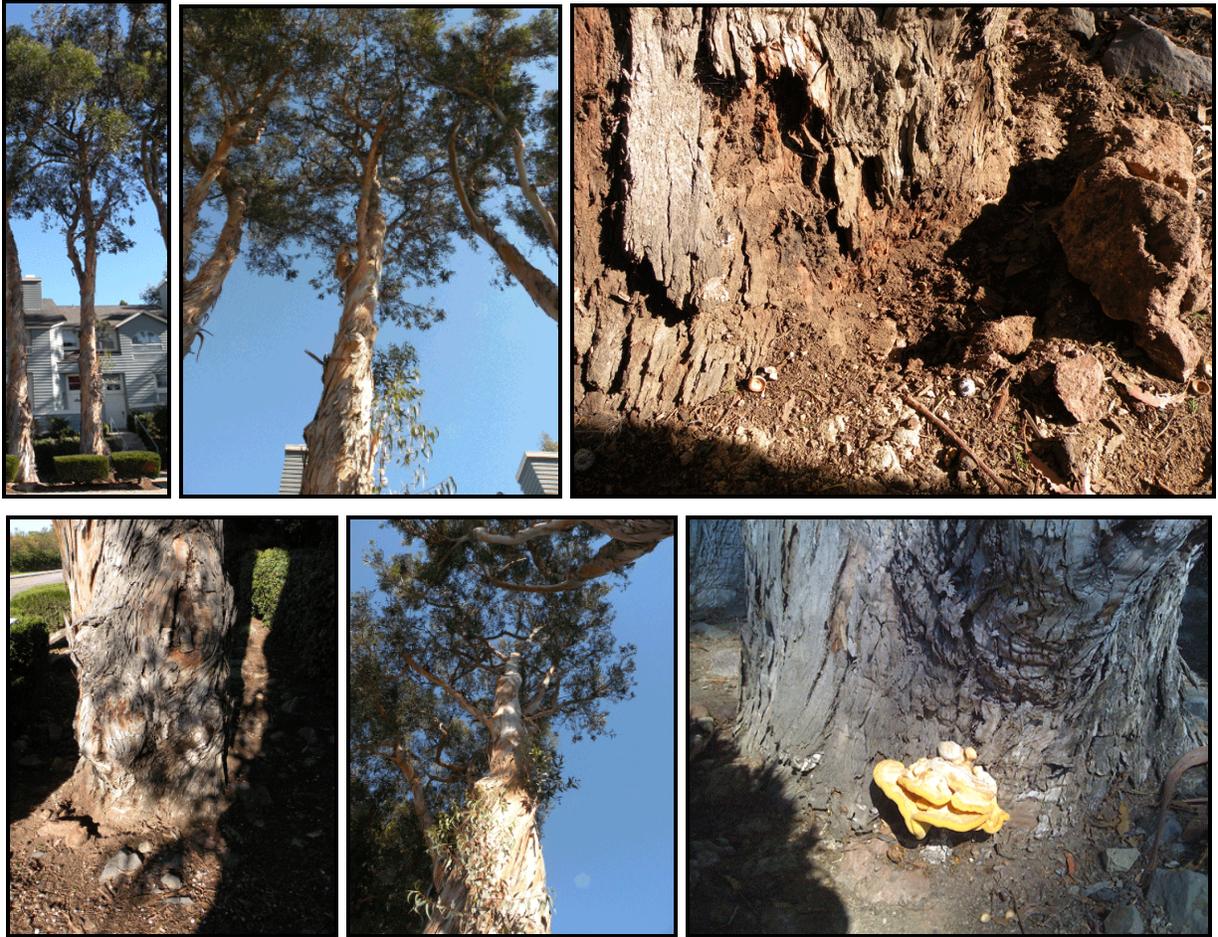
Tree 14

Only one tree is considered a potential safety hazard at this time, Tree #14, the third tree from the corner of Sullivan and Goodman Streets. Several other trees, including #s 1, 3, 4, 5, 7, 8, 10, 12, and 31, may be safety hazards due to weak structure or wounds that could expand and cause a portion of the tree to break off.

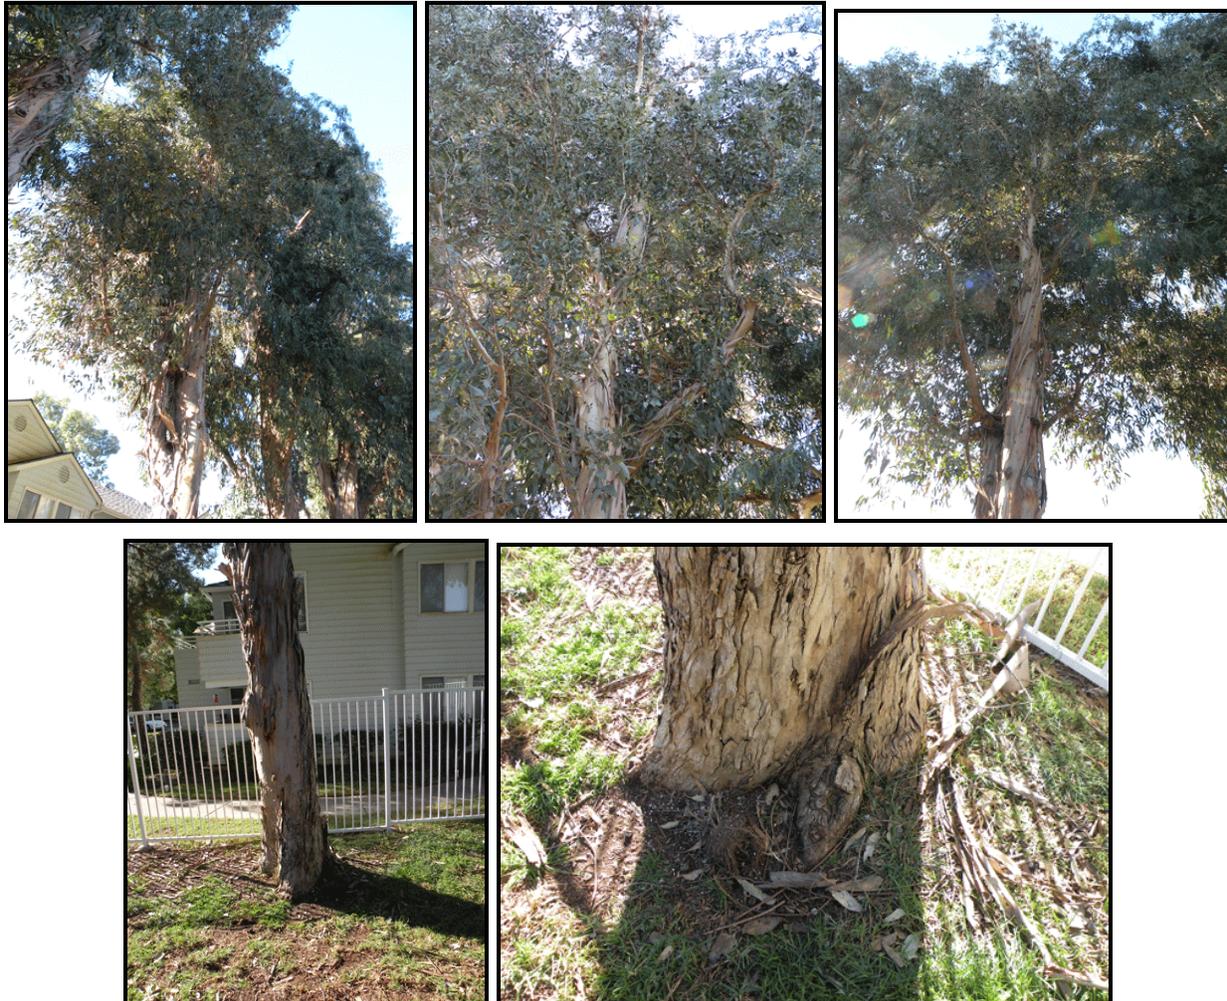
Tree 23

Tree #23 does not need any special treatment or maintenance at this time.
