CALLEGUAS CREEK WATERSHED WETLAND RESTORATION PLAN

October 2000

David Magney Environmental Consulting

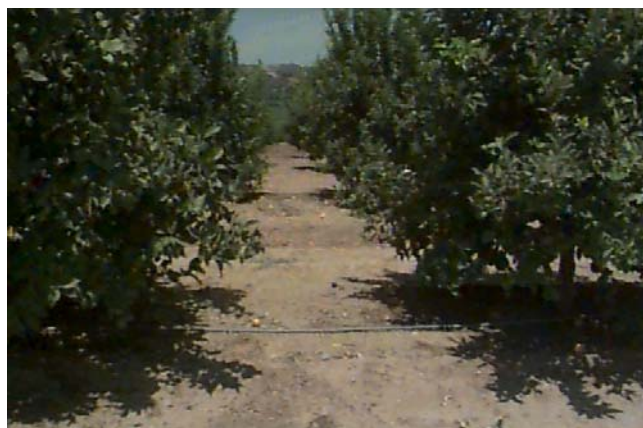
Photograph 8. Typical Orchard with Little Understory Vegetation

Citrus orchard along Santa Rosa Road with a barren understory that can readily loose topsoil.

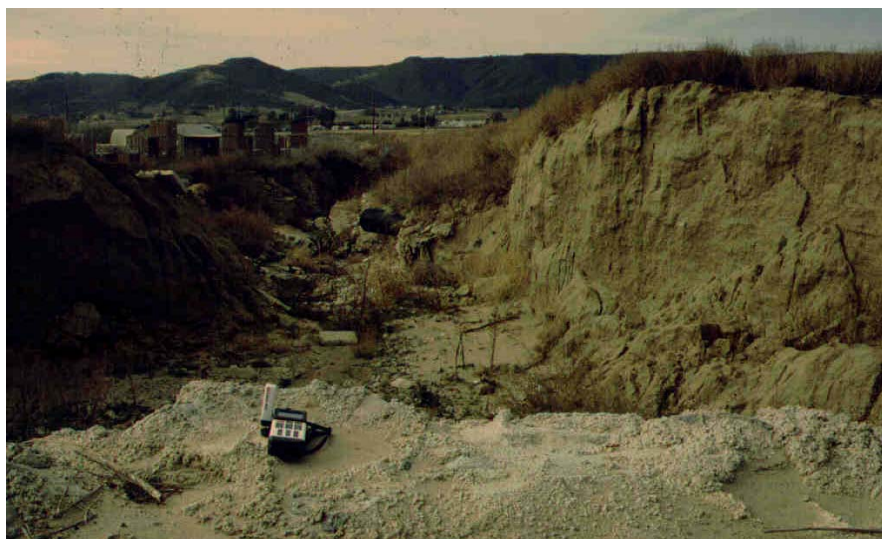
Photograph 9. Scour and Bank Erosion Under and Downstream of an Undersized Culvert

Stacking water up stream increases stream stage (i.e. stream water surface elevation) and can lead to increased flood hazards. Additionally, stacked waters have lower flow velocities, reduced stream powers, and reduced sediment transport capacities (Dabney et al. 1995, Meyer et al. 1995). Thus, sediment is deposited upstream from undersized culverts and bridge spans leading to a reduction in channel capacity (Photograph 10, Sediment Deposition Upstream from an Undersized Culvert).

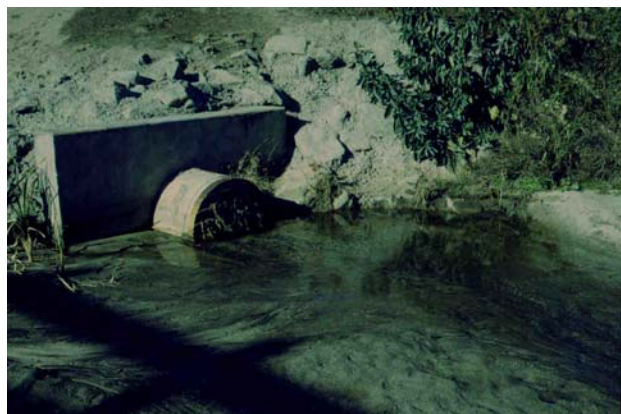
Photograph 10. Sediment Deposition Upstream from an Undersized Culvert

Undersized culverts and bridge spans are chronic problems throughout the Calleguas Creek Watershed. In fact, the inventory data set has numerous examples of undersized culverts and bridge spans including, but not limited to, Sites 9, 10, 12, and 36. Removal or redesign and reconstruction of these crossings using sound hydraulic analyses can provide incremental benefits at the watershed-scale. Furthermore, the use of sound hydraulic analyses in the construction of new culverts and bridge spans can prevent further degradation.

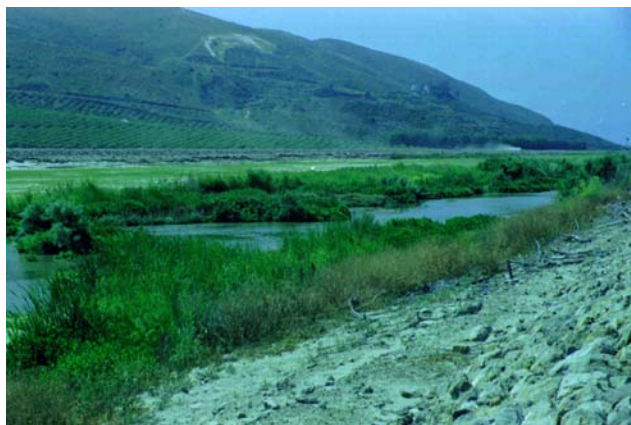
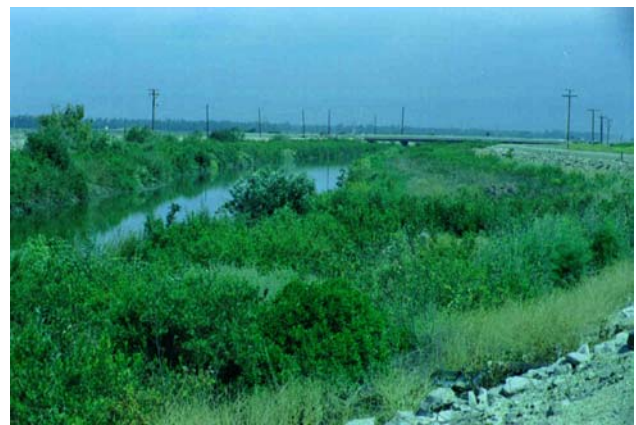
Photograph 11. Current Conditions of Calleguas Creek/Revolon Slough Confluence

a. Downstream view of Calleguas Creek from levee

b. Upstream view of Revolon Slough on levee

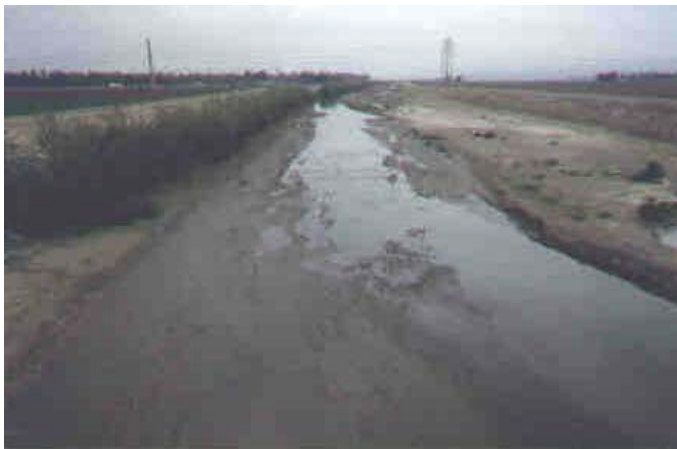
Photograph 12. Current Conditions of Calleguas Creek at CSU Channel Islands (Site 1)

View upstream of levee-confined channel bounded by agriculture.

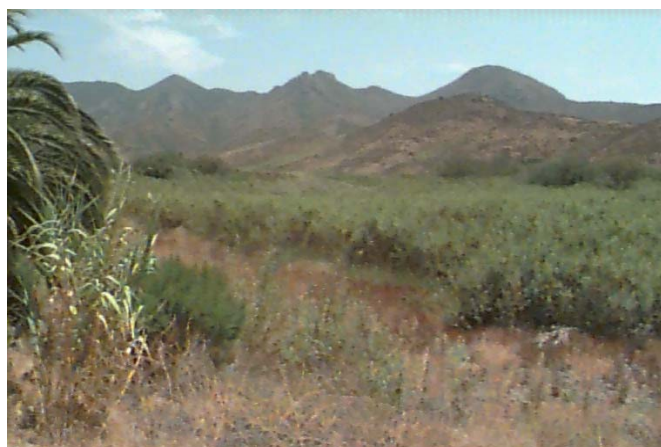
Photograph 13. Current Conditions of Calleguas Creek at Camarillo Regional Park (Site 34)

Very little vegetation restoration would be required on the historical floodplain since so much native, hydrophytic vegetation persists. However, portions of the active floodway and the adjacent uplands would be revegetated with native species characteristic to the region and landscape position. Plant communities may include, but are not limited to, California Bulrush Series, Arroyo Willow Series, and Cattail Series in the active floodway and a mosaic of Mulefat-Coyote Brush Series, Blue Elderberry Series, and California Sagebrush-California Buckwheat Series in the uplands (Sawyer and Keeler-Wolf 1995) (Figure 24, Conceptual Restoration Design for Calleguas Creek at Camarillo Regional Park [Site 34]).

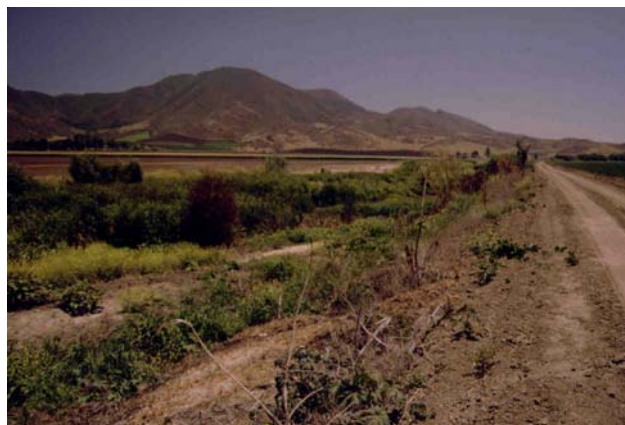
Photograph 14. Current Conditions of Arroyo Conejo at Winding Brook Farm (Site 35)

a. View southeastward of lower reach of Arroyo Conejo, where riparian vegetation is periodically cut down.

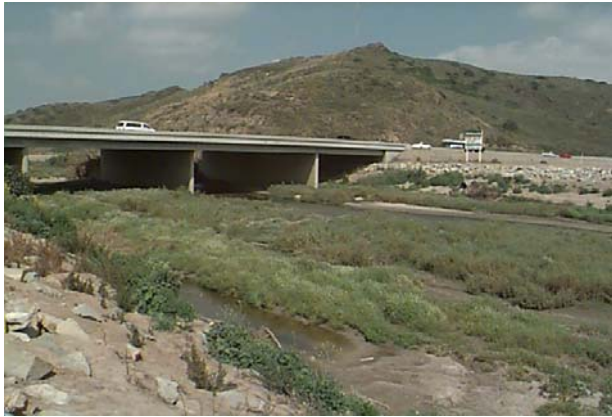
Photograph 15. Current Conditions of Arroyo Conejo at U.S. 101 (Site 43)

a. View north at U.S. 101 bridge over Arroyo Conejo

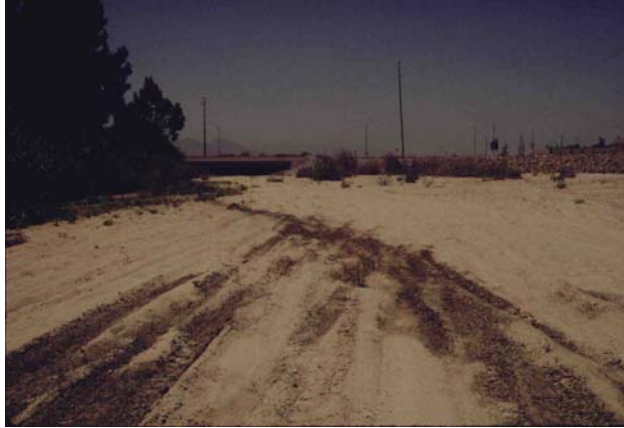
**Photograph 16. Current Conditions of Calleguas Creek
from Somis to Upland Road (Site 25/37)**

a. View downstream towards Upland Road of channel bed full of sediments and little vegetation.

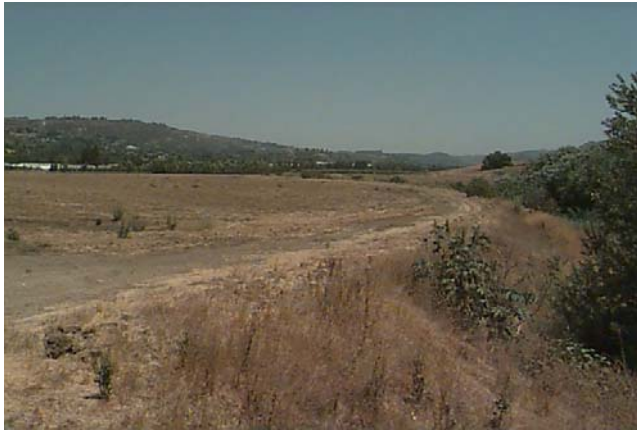
Photograph 17. Current Conditions of Arroyo Santa Rosa at Arroyo Conejo (Site 30)

a. View upstream of area north of Arroyo Santa Rosa

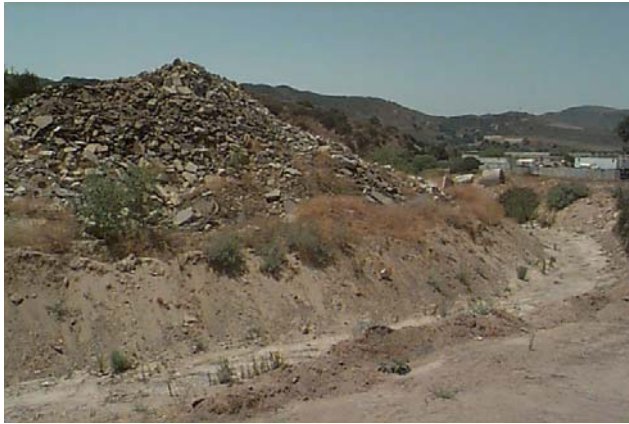
Photograph 18. Current Conditions of Arroyo Simi at Simi Recycling Center (Site 18)

a. View southeast of Southdown Concrete Products facilities on fill placed in Arroyo Simi floodplain

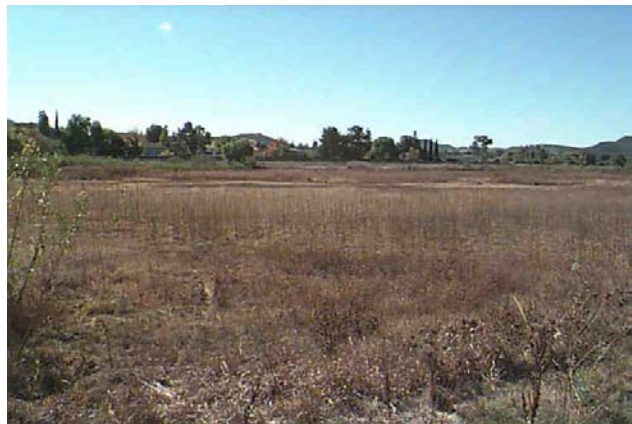
Photograph 19. Current Conditions of Arroyo Conejo at Borchard Road (Site 47)

a. View westward from near middle of site, which is predominantly isolated wetland habitat.

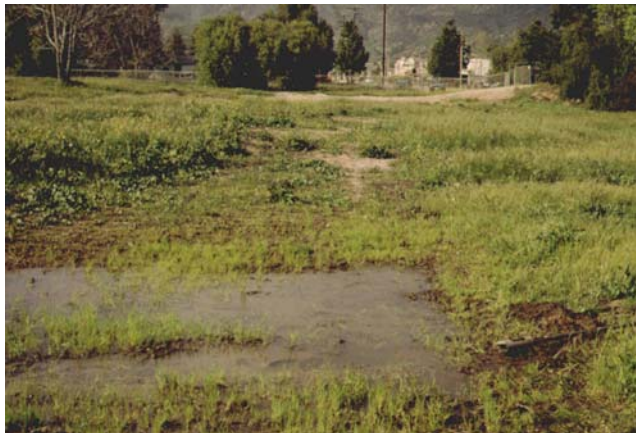
Photograph 20. Current Conditions of Arroyo Simi/Junipero Channel Confluence at Kuehner Road (Sites 40/41)

Furthermore, nesting sites were recorded for the White-throated Swift, the Violet-green Swallow, and the Cliff Swallow. Insofar as DMEC knows, this is the lowest known nesting site for the Black-throated Swift in southern California. Kuehner Road spans Arroyo Simi upstream, and Smith Road spans Arroyo Simi downstream. There are residential neighborhoods to the west and north. There are no other major structures on the site.
