WETLAND FUNCTIONAL ASSESSMENTS OF THE CAMARILLO REGIONAL PARK WETLAND AND GOLF COURSE PROJECTS, VENTURA COUNTY, CALIFORNIA

Wetland Functional Assessments of the Camarillo Regional Park Wetlands and Golf Course Projects, Ventura County, California

24 August 2004

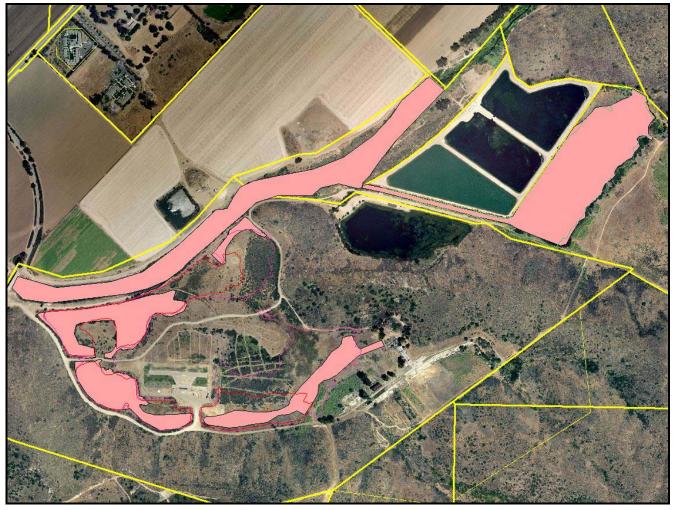
Figure 3. Camarillo Regional Park Wetlands as Delineated by Impact Sciences

The rose-colored areas indicate the approximate boundaries of Impact Sciences 1997-98 wetland delineation, with both Corps and CDFG wetlands included, totaling 53.7 acres of mapped wetlands, which includes Calleguas Creek. DMEC digitized the boundaries onto the July 2003 aerial photograph from Impact Sciences' Figure 6, and minor errors during the transposition from one map source (Impact Sciences 1998 map at $1^{"}=6,600$) are likely to have occurred during the digitization process. The red and magenta lines represent the 68- and 70-foot contours, respectively, while the greenish and tan lines represent the 82- and 84-foot contours, respectively. The yellow lines are parcel boundaries.

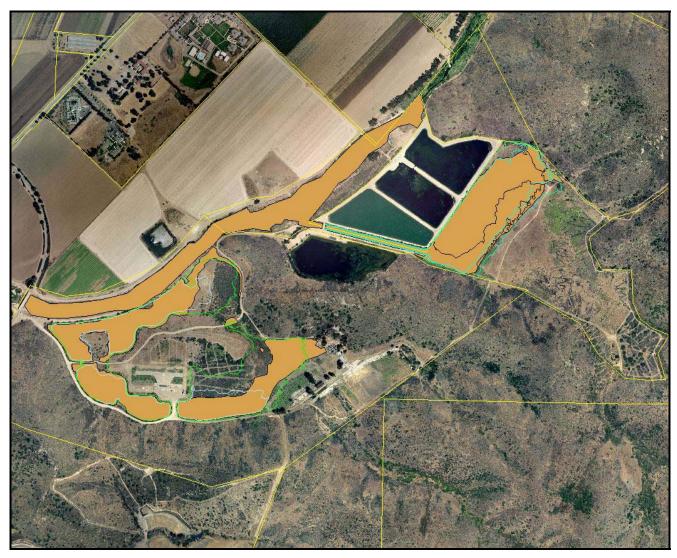
Figure 4. Probable Area of Jurisdictional Wetlands at Camarillo Regional Park

The mustard-colored areas represent areas DMEC expects to be Corps jurisdictional wetlands, totaling 73.2 acres. Additional wetlands as defined by CDFG and the County of Ventura would likely include the boating pond. The light blue and bright green lines are the 68- and 70-foot contours in the southern valley, respectively, while the aqua and bluish lines in the northern valley are the 82- and 84-foot contours, respectively. The yellow lines represent parcel boundaries as of 1998. Compare this figure with Figure 3, which illustrates the area of wetlands delineated by Impact Sciences, showing a total of only 53.7 acres, including Calleguas Creek.

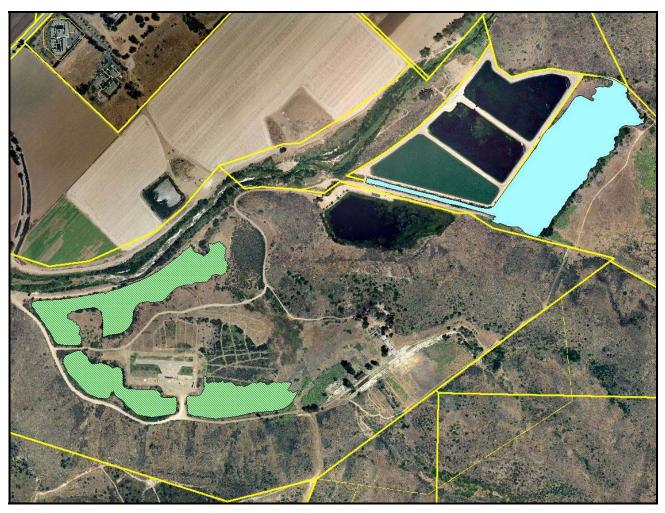
Figure 5. Seasonally Ponded and Saturated Low-laying Areas of Camarillo Regional Park

The green areas are those low-laying areas that occur at or below the 68-foot contour interval, and where surface water ponds during the winter and spring months, excluding Calleguas Creek. The light blue area includes land at or below the 82-foot contour interval, and where the soil is known to be saturated during the winter and spring. These areas are almost certainly within the Corps' jurisdiction as wetlands. The yellow lines are parcel boundaries.

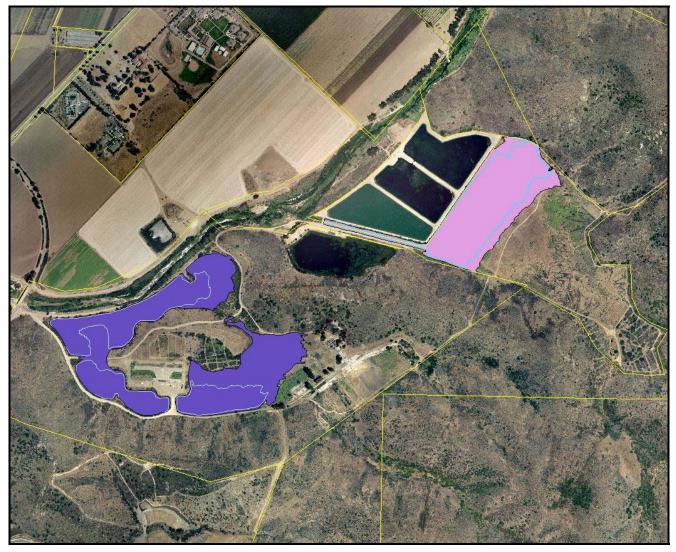
Figure 6. Additional Ponded/Saturated Low-laying Areas of Camarillo Regional Park

This map is similar to Figure 5; however, the areas in the southern valley of the park at or below the 70-foot topographic contour are shown in purple. The lavender-colored area in the northern valley illustrates that portion at or above the 84-foot topographic contour interval. The areas below the 68-foot and 82-foot contours (light blue lines) are included, as shown on Figure 5. The areas between the 68- and 70-foot and 82- and 84-foot contours, respectively, also contain hydrophytic vegetation in some areas and are possibly considered wetlands by the Corps, and likely meet the CDFG's and County's definitions of wetlands. The areas between the 68- and 70-foot, and between the 82- and 84-foot contours, are expected to pond water for a long duration at least during years with higher-than-average rainfall.

Figure 6, Additional Ponded/Saturated Low-laying Areas of Camarillo Regional Park, illustrates the areas of the park DMEC delineated that also contain one or more wetland criteria. Figure 6 shows the 70-foot contour interval in the southern valley of the park, and the 84-foot contour interval in the northern valley to compare those areas with onsite hydrophytic vegetation and landscape position.

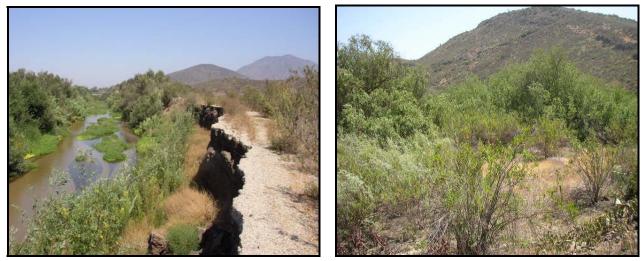
Figure 7. Photographs of Wetland Habitats at Camarillo Regional Park

Left (7a): Calleguas Creek at eroded levee adjacent to southern valley, view NW. Right (7b): Southern Willow Scrub wetland habitat in lowland area of southern valley of Camarillo Regional Park. Dated 6-May-2004.

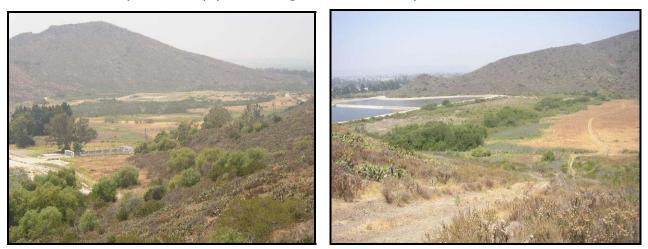
Left (7c): Southern valley of park from central dividing ridge, view SW, with Coastal Sage Scrub in foreground. Right (7d): Northern valley from central dividing ridge, view NW. Two northernmost Camrosa ponds visible downslope (WNW) of Alkali Meadow and Southern Willow Scrub habitats; Ruderal grassland seen on right side of photo. Dated 3-Jun-2004.

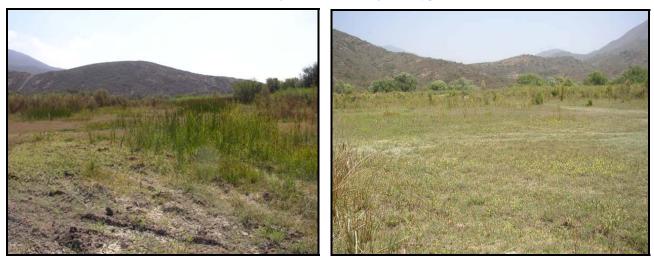
Left (7e): Photo of Alkali Meadow wetland in northern valley, view southward, dated October 2002. Right (7f): Alkali Meadow wetland, view northward, dated 6-May-2004. Note salt precipitates on soil surface.
