**ASSESSMENT OF
EUCALYPTUS TREES AT CAPE MASTER
AND THE CAPE DEVELOPMENTS**

April 2009

David Magney Environmental Consulting

17 April 2009

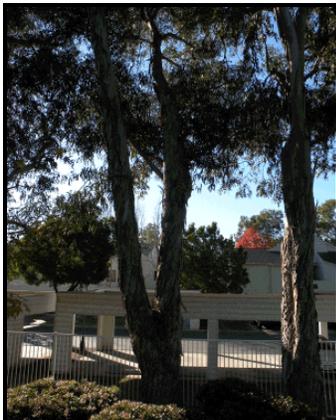
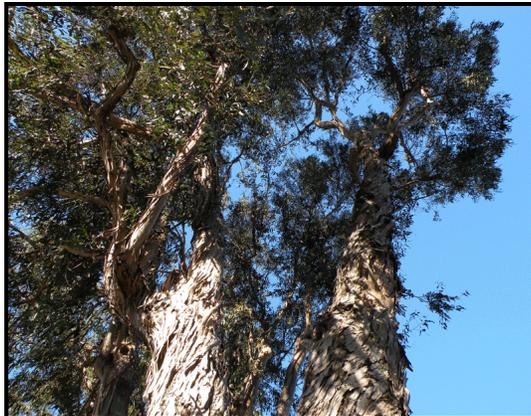
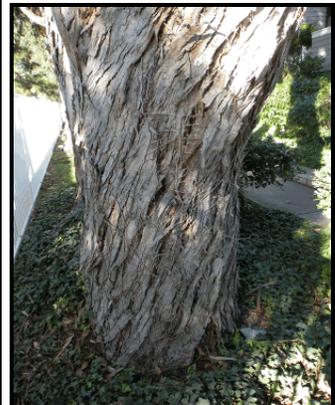
Tree 31

Only one tree is considered a potential safety hazard at this time, Tree #14, the third tree from the corner of Sullivan and Goodman Streets. Several other trees, including #s 1, 3, 4, 5, 7, 8, 10, 12, and 31, may be safety hazards due to weak structure or wounds that could expand and cause a portion of the tree to break off.
